The Glitch & The Fix — January 2009 by John Siegenthaler, P.E.

The Glitch

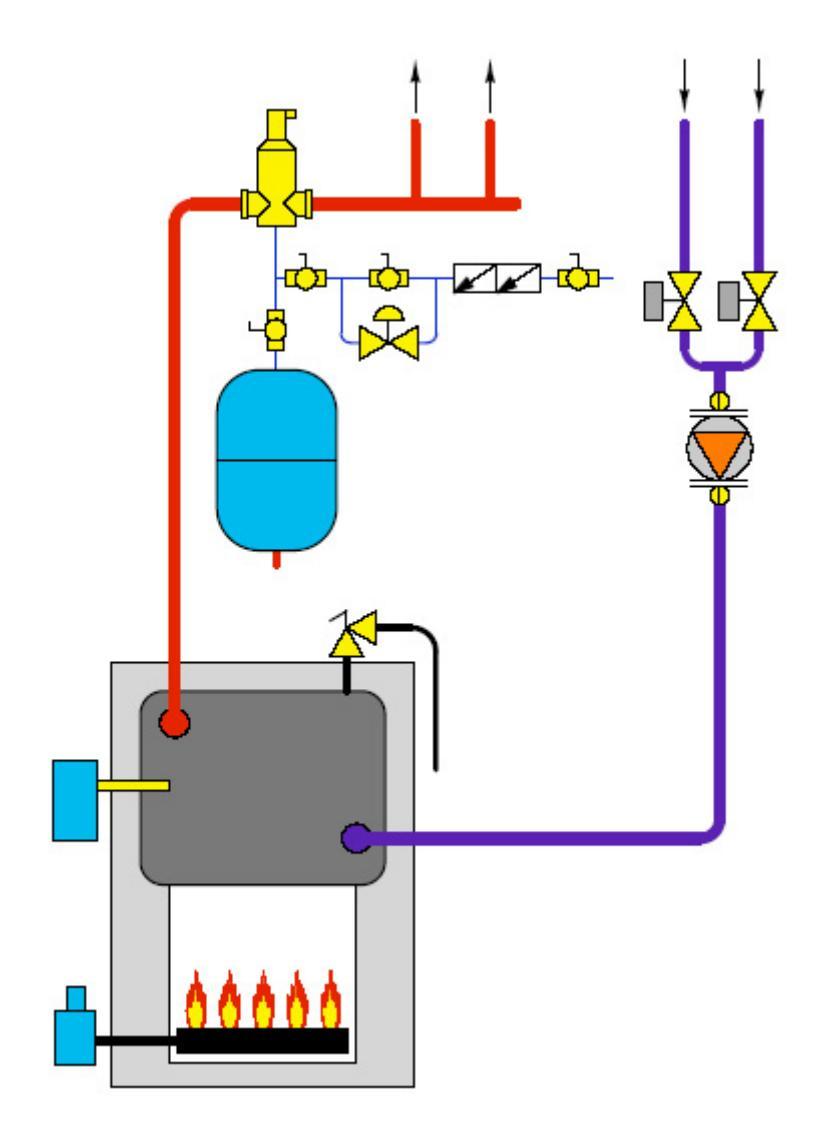
Overview: At one point in time, the schematic shown below appeared in a manufacturer's installation manual. It represented their recommendations on installing a two-zone system.

1. The zone valves should be located on the supply side of the zone circuits to eliminate heat migration into inactive zone circuits.

2. The tee shown below the zone valves is a "bullhead" tee. When both zones are on, return flows slam directly into each other. This creates turbulence and noise. It also wastes circulator head.

3. There should be at least 12 diameters of straight pipe leading into the circulator. Placing it close to the side port of the bullhead tee allows turbulent flow into the circulator. This decreases circulator performance and creates noise.

4. The circulator in the glitch drawing is pumping *toward* rather than away from the expansion tank. This causes a decrease in pressure within the zone circuits when their circulators operate.

5. There is no provision for differential pressure control in the original system.

6. There are no purging valves in the original system.
