June 2010 Glitch & Fix

Radiant Floor Heat And Mod/Con Boilers

The Glitch

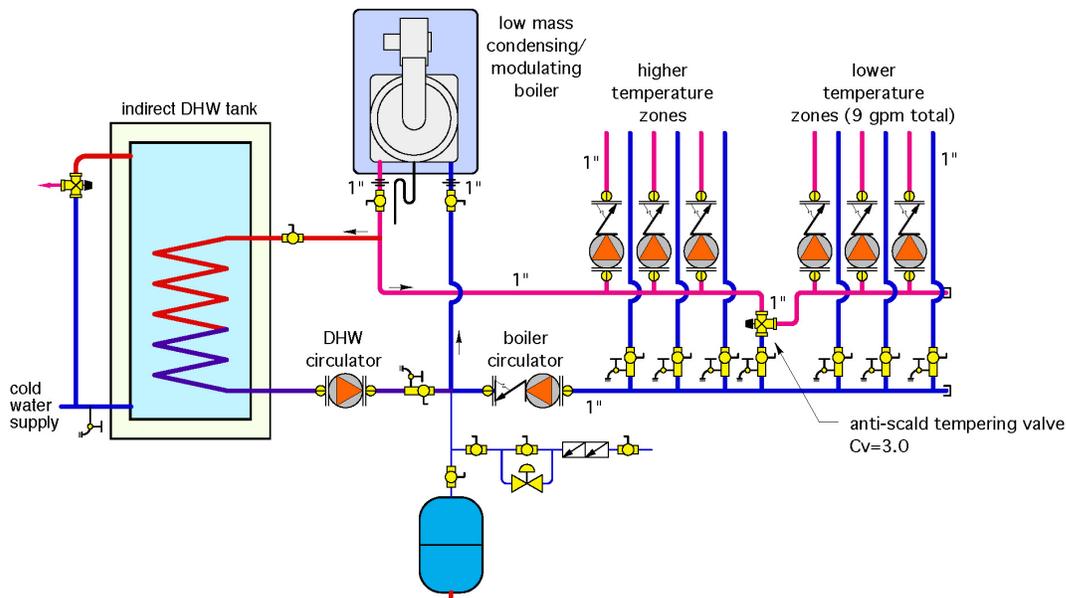
A project requires both medium- and low-temperature radiant floor panels. The installer proposes the following system design. Since the mod/con boiler already has an internal outdoor reset controller, he decides to use a standard 1-inch tempering valve to lower the water supply temperature to the lower temperature zones. He also decides that since the boiler supply and return connections are 1 inch, he can pipe the entire system with 1-inch tubing.

Can you spot at least six design or installation details that are going to create problems?
