The Glitch

Overview: A solar combisystem is being planned to provide a portion of the space heating and domestic hot water needs of a new “Eco” house being constructed in Vermont. The house will have plenty of south-facing windows to help warm it on sunny winter days.

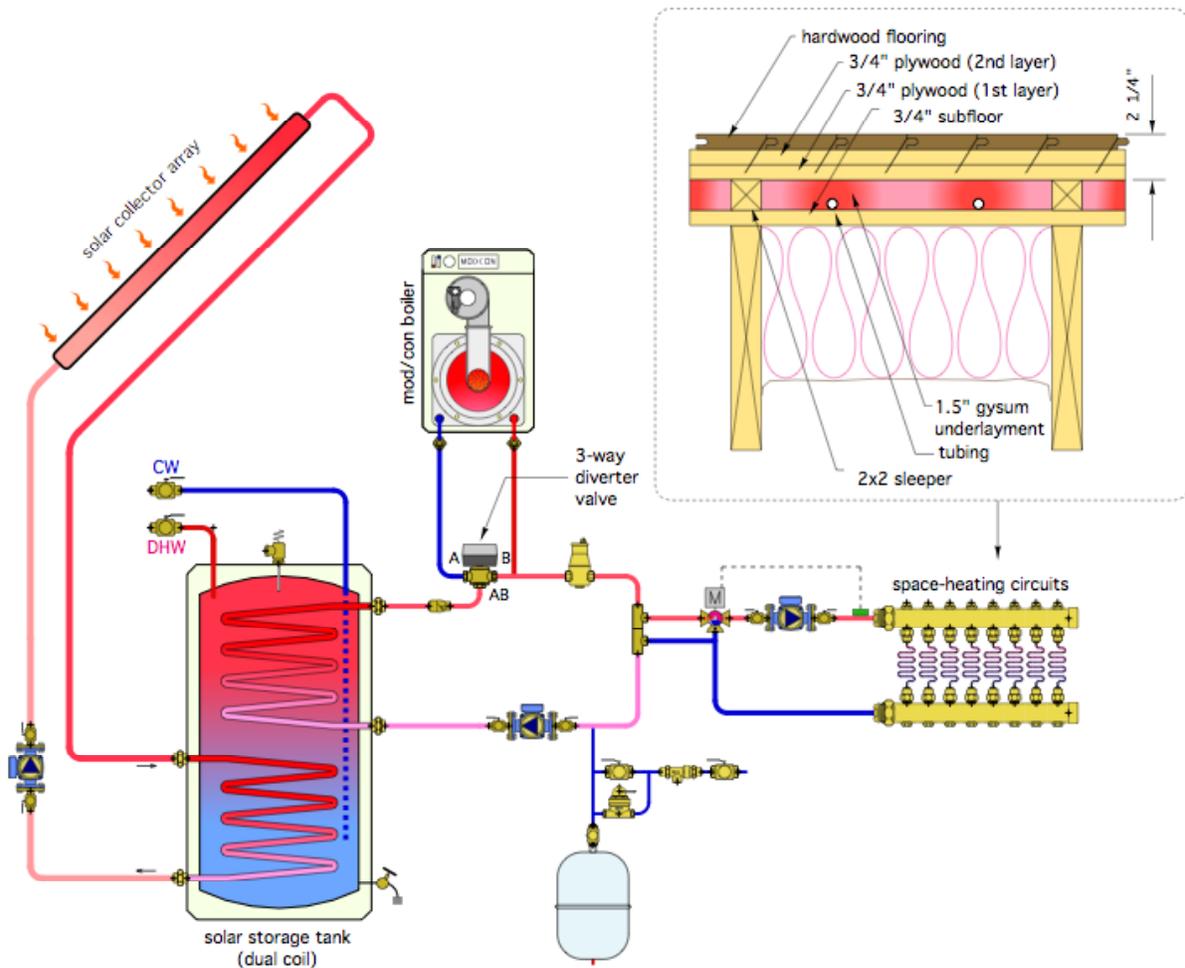
The owner loves the idea of warm floors, but also wants nail-down hardwood flooring. The flooring contractor plans to install that floor as shown in the cross-section below (because he saw this detail in a major home building publication).

Exercise: Look over the schematic and the planned floor installation detail. Do you see any problems lying in wait?

The flooring installation detail shown did appear in a major building publication. It's the result of asking a flooring specialist (rather than a heating specialist) how the flooring should be installed over a radiant panel.

The flooring installer doesn't want any issues with keeping that floor flat, so he specifies two overlapping layers of 3/4" plywood for the underlayment. This adds considerable thermal resistance between the water in the tubes and the top surface of the floor. This significantly increases supply water temperature, especially at design load conditions.

Although such a floor would probably operate adequately at design load conditions if supplied with water in the 160 °F range, such temperatures are quite presumptuous for a solar system using flat plate collectors during a cold Vermont winter. The solar energy contribution to space heating in such a system will be very limited.

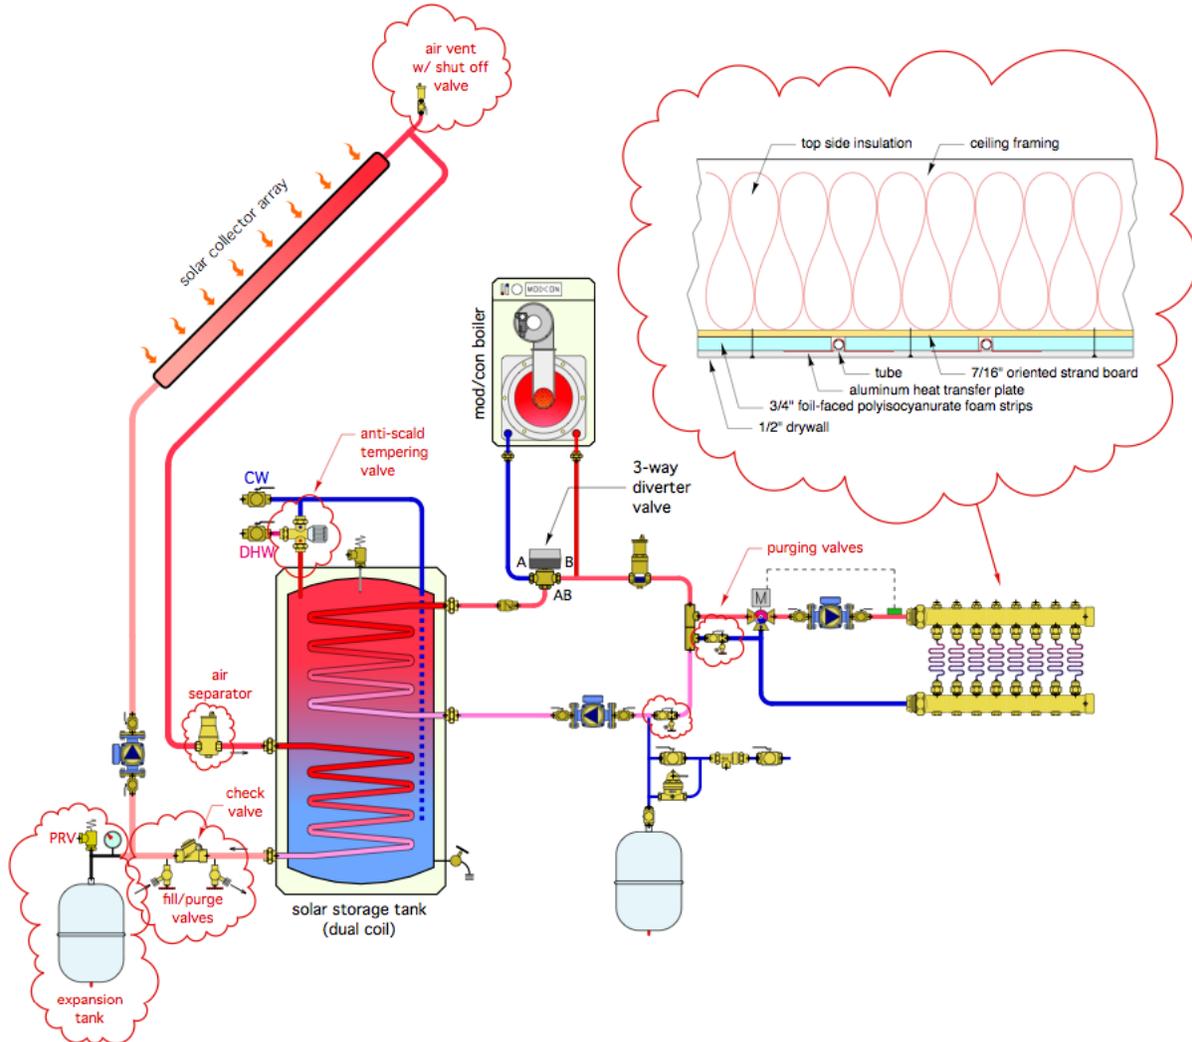
The Fix

A low mass radiant panel (such as the ceiling panel shown in the Fix drawing) would be a far better choice. Its low thermal mass responds quickly to internal heat gains, which are likely in a house with lots of south-facing windows. This panel also has much lower thermal resistance than the construction shown in the Glitch drawing, and thus will operate at lower supply water temperatures. This means higher collector efficiency and greater energy yield from the solar subsystem.

The original piping schematic is also missing several essential components in the solar collector circuit. It also lacks an anti-scald tempering valve on the domestic hot water piping and purging valves in the space heating system. These components are identified in red on the Fix drawing.
